# ASSET MANAGEMENT PLAN

## ROAD NETWORK AND BUILDINGS/STRUCTURES

The Township of North Algonia Wilberforce  
1091 Shaw Woods Road RR1  
Eganville, ON  
K0J 1T0

McIntosh Perry Consulting Engineers Ltd.  
115 Walgreen Road  
Carp, ON  
K0A 1L0

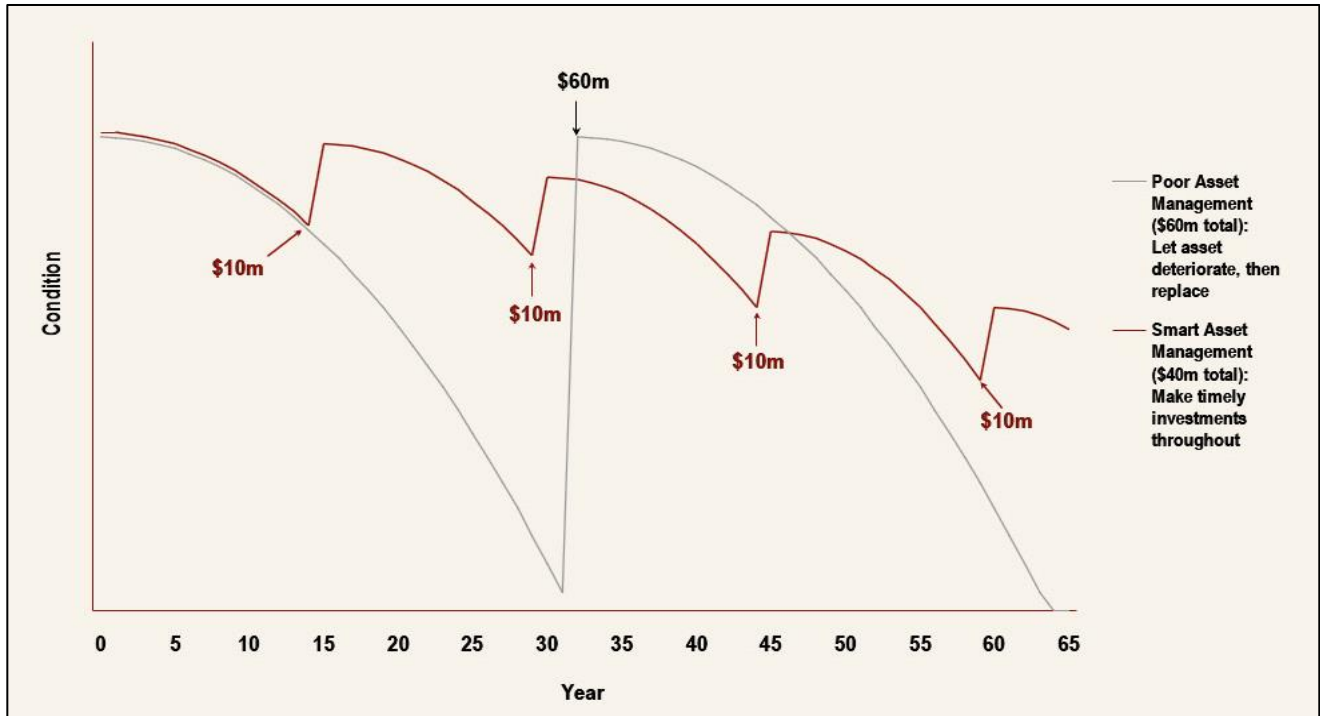
Figure 1: Lifecycle of Two Renewal Options<sup>1</sup>

An asset management plan should take a long view perspective on managing the asset through life cycle cost analysis in which timely maintenance and rehabilitation can save money in the long term. For example, Figure 1 shows two ways to manage an asset. The first option is to allow the asset to deteriorate until it needs to be replaced, while the second option shows timely rehabilitation. At the end of the 64-year life cycle, Option 1 costs \$120 million (the initial investment plus the cost to replace the asset) and Option 2 costs \$100 million. Note that the asset's condition in Option 2 is far better than in Option 1.

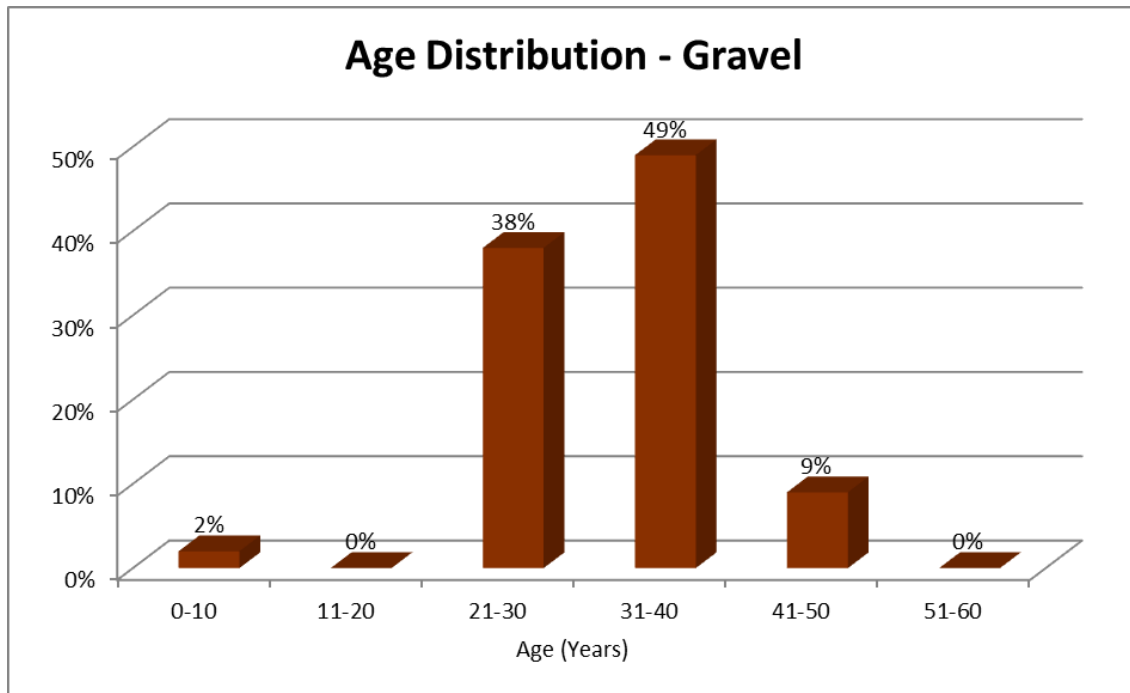
**FIGURE 3 - AGE DISTRIBUTION - GRAVEL ROADS**

The age distribution for gravel, surface treatment (LCB) and asphalt (HCB) roads is presented in Figures 3 to 5. The average remaining life of each asset type is presented in Table 12.

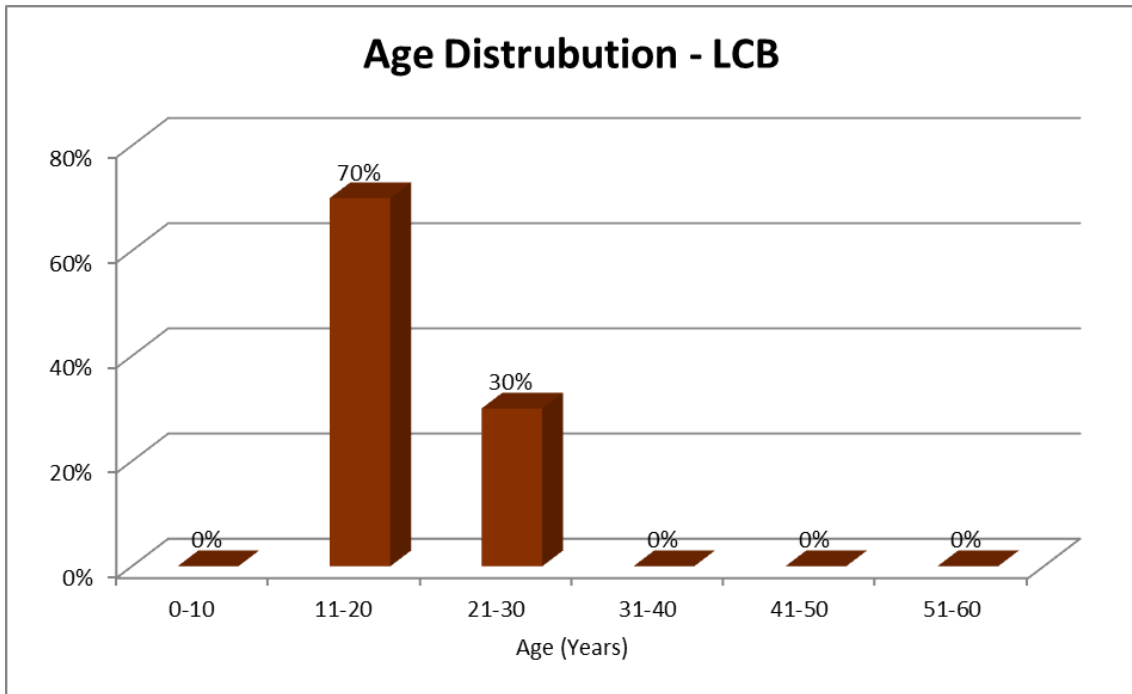
FIGURE 4 - AGE DISTRIBUTION - SURFACE TREATED ROADS (LCB)

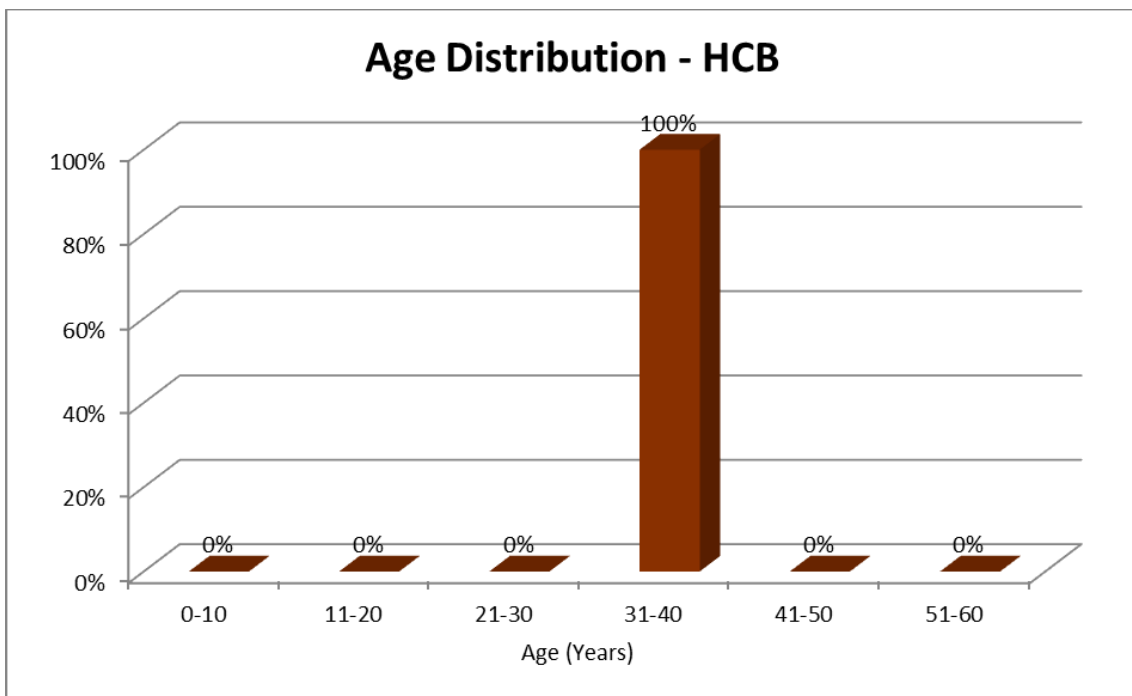
FIGURE 5 - AGE DISTRIBUTION - ASPHALT ROADS (HCB)

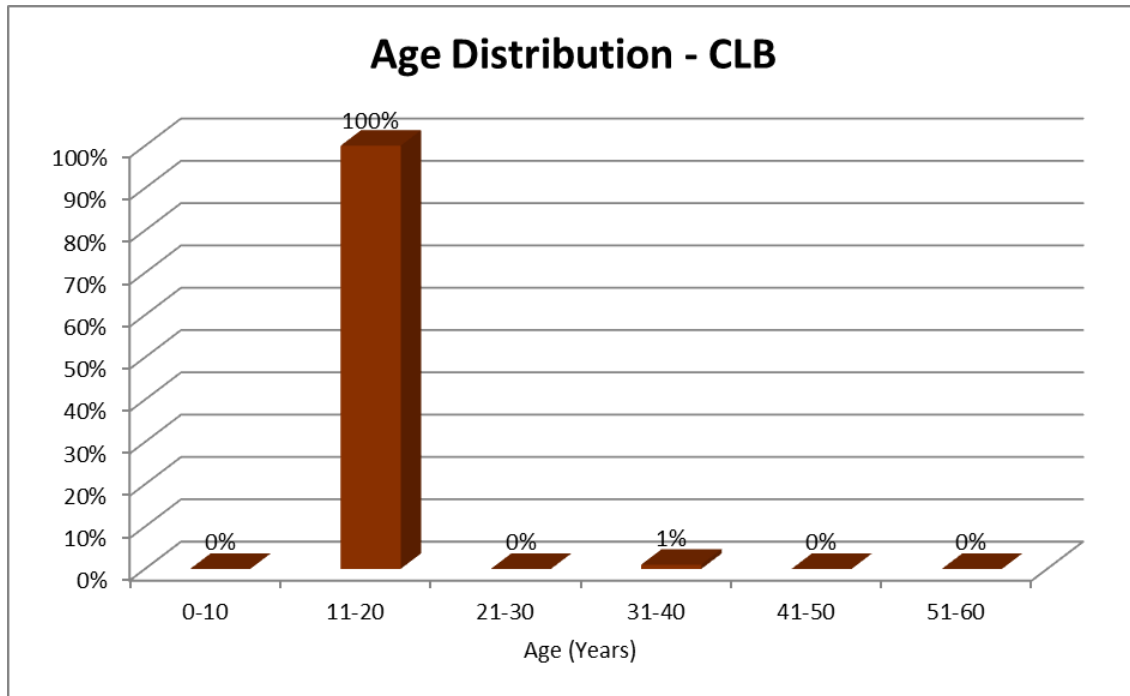
FIGURE 6 - AGE DISTRIBUTION – COLD LAID (CLB) ROADS

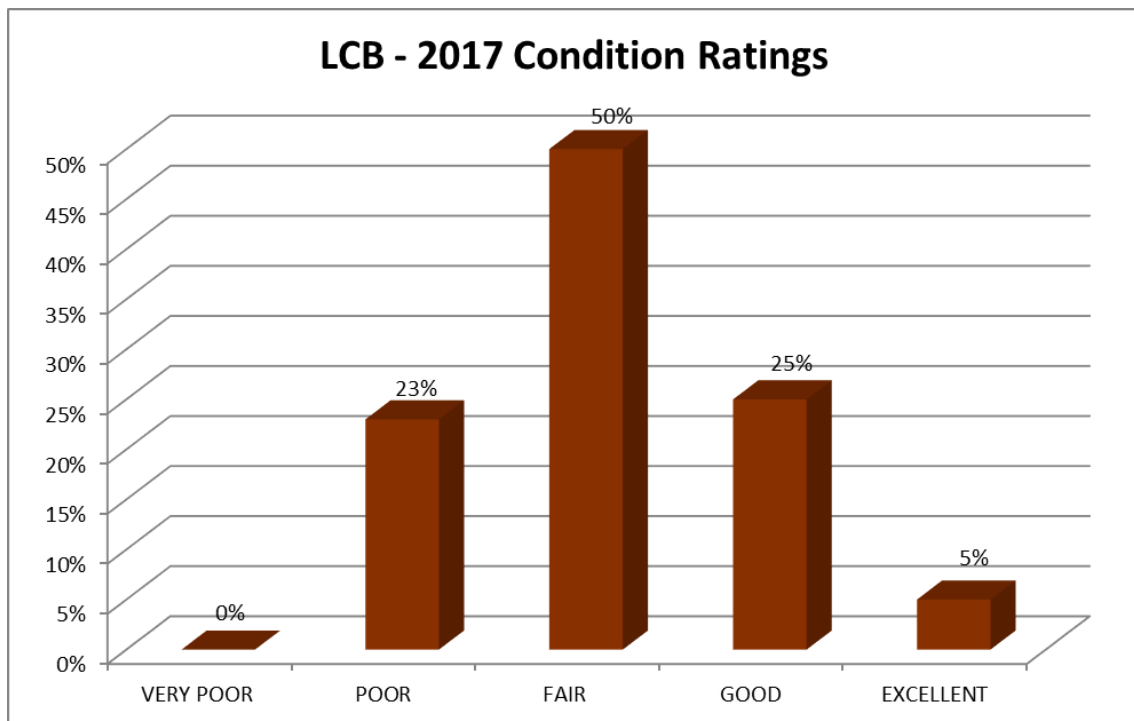
FIGURE 8 - CONDITION RATING DISTRIBUTION - SURFACE TREATED ROADS (LCB)

Figures 7 - 10 present the condition of each road type. The overall average structural condition of North Algona Wilberforce’s road system at the time of this report is Fair, based on an overall rating of 5.94. Map 2 shows the now deficient roads, i.e. roads with a condition rating of less than 5.0 in 2017.

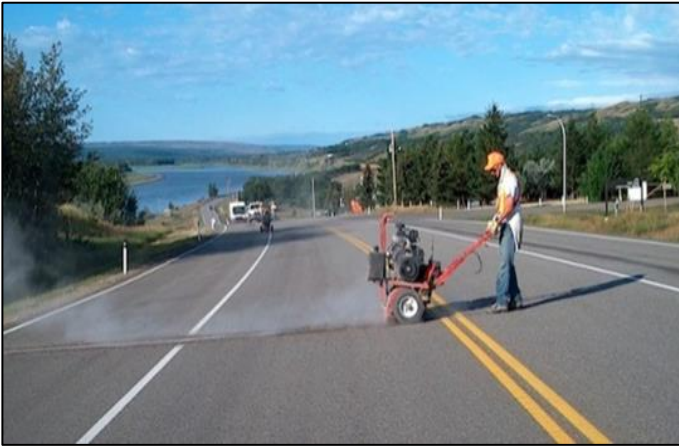
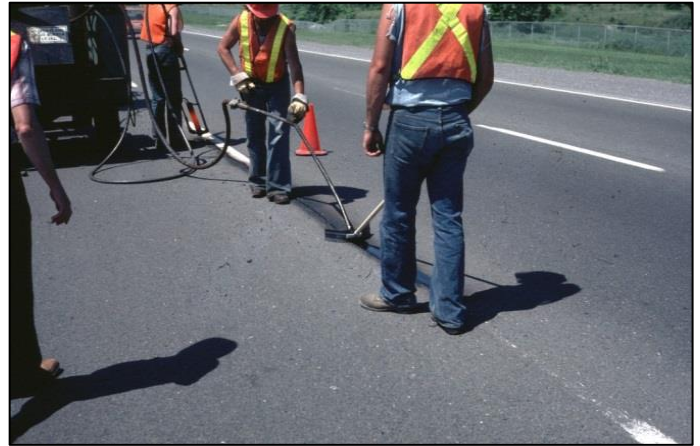
#### 4.2.1 Rout and Seal

**Description:** Rout and seal involves routing of cracks to a standardized size, cleaning and heating of routed cracks with a lance, followed by hot poured rubberized asphalt including squeegee. By keeping the water out, it prohibits freeze/thaw reactions in winter, and guards against reduced strength due to water infiltration at other times, thus retarding the development of alligator cracks.

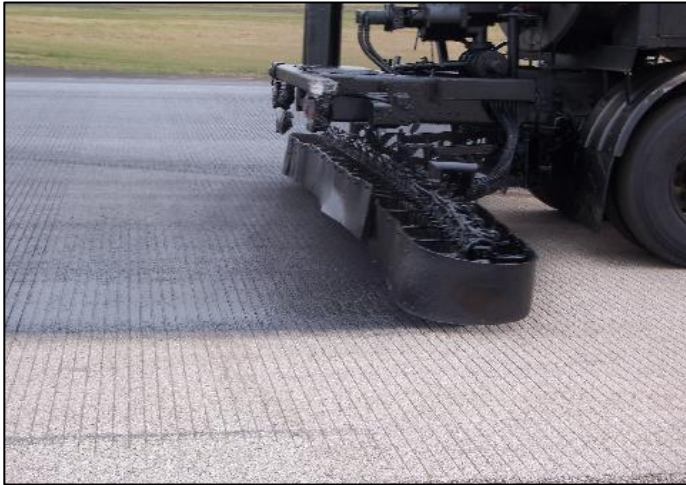
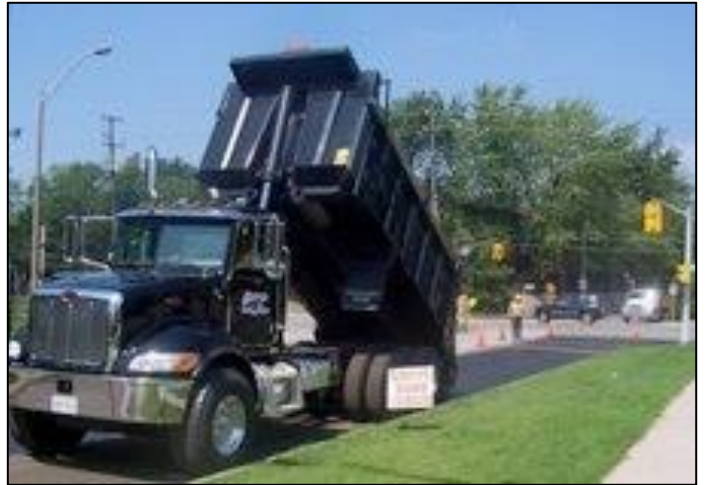
#### 4.2.2 Rejuvenating Oil

**Description:** Rejuvenating oil penetrates an asphalt surface and restores the maltene to asphalt ratio, extending the life of the surface. Following application and prior to traffic, a layer of manufactured sand is applied to provide temporary friction. This is subsequently swept up and reused.
